**GEO-PHYSICAL WELL  
ELECTOLOGGING REPORT**

Ref No:-A-2134

GRAM PANCHAYAT- IKRI, BLOCK- JAGAT, DISTT- BADAUN  
UNDER  
JAL JIVAN MISSION

A Deep bore hole was drilled 140 mtrs. depth. and Logged depth 140 mtrs. at above site. Was drilled by M/S PNC-SPML-JV, Badaun.

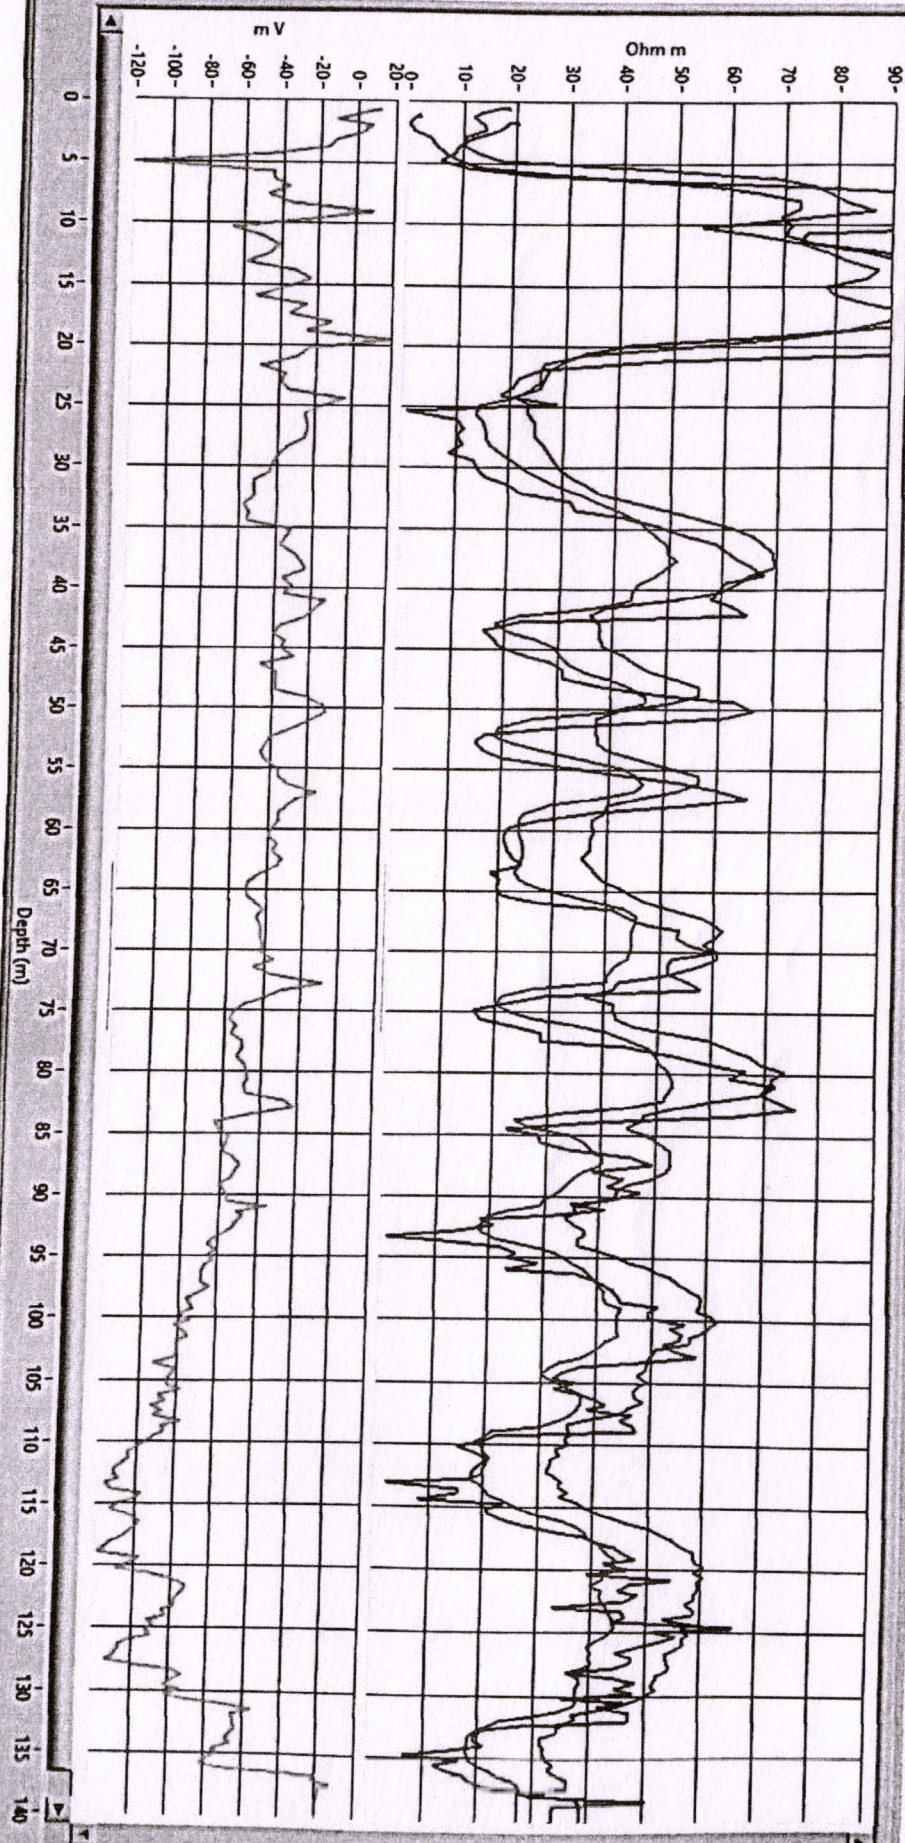
Rho a

- N16 (SM)
- N64(Q/N)
- LAT

Logging Details:

Logger S/N: IG/S/01/21-22

Logger Model: SP (m V)

Logging Para meters - Self potential, short normal (N-16), Long Normal (N-64), Lateral. Details of major aquifer formations explored from logging of bore hole combined with the study of Strata Chart prepared from drill cuttings are given in the following table:-

S.No.	Depth range(m)	Thickness(m)	Lithology	Expected Water Quality
1.	0 - 5	5	Surface soil	
2.	5 - 20	15	Dry sand	
3.	20 - 34	14	Clay kankar	
4.	34 - 40	6	Medium sand	Medium
5.	40 - 48	8	Clay kankar	
6.	48 - 50*	2	Medium sand	Medium
7.	50 - 55	5	Clay kankar	
8.	55 - 57*	2	Medium sand	Medium
9.	57 - 66	9	Clay kankar	
10.	66 - 72*	6	Medium sand	Medium
11.	72 - 76	4	Clay kankar	
12.	76 - 83*	7	Medium sand	Medium
13.	83 - 85	2	Clay kankar	
14.	85 - 88*	3	Fine to Medium sand	Medium
15.	88 - 95	7	Clay kankar	
16.	95 - 108*	13	Medium sand	Medium
17.	108 - 116	8	Clay kankar	
18.	116 - 130*	14	Medium sand	Medium
19.	130 - 140	10	Clay kankar

1. The Lithology broadly tallies with that of drill cutting starta chart.
2. The zones marked with asterisk (\*) appear to be aquifer zones for possible development of tube well.
3. The Quality of water is expected Medium.
4. It is recommended to have a chemical and bacteriological analysis of the water sample before using it for human consumption or for any other use.
5. All projections and recommendations are subject to the inherent limitations of the technique employed and there could be variations as the underground conditions are not always amenable to physical interpretations.
